August 8, 2007 Storm Report

I. Executive Summary

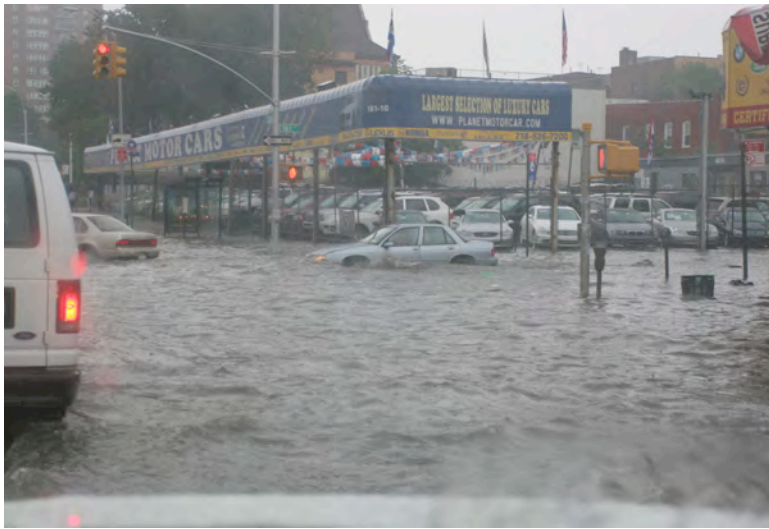
Figure 4
*F Line Hillside Ave
Flooding*

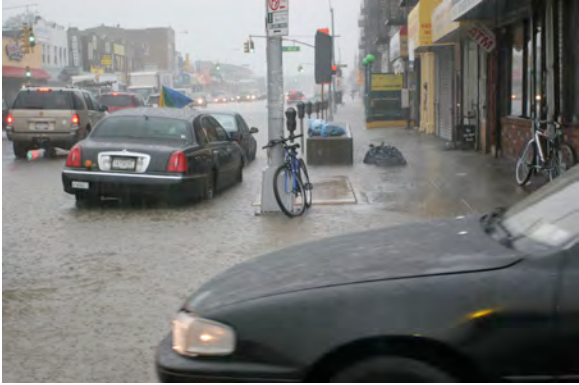
Figure 1
F Line Hillside Ave Flooding

A promising permanent alternative is to create vent structures that will physically raise the grates and thereby prevent the water from entering the subway. Past efforts, such as the trial elevated vent structure installation along Hillside Avenue on Queens Boulevard (as seen in Figure 1) have raised neighborhood aesthetic issues.

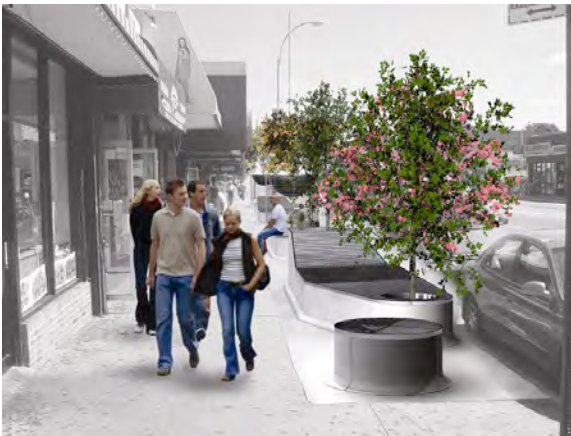
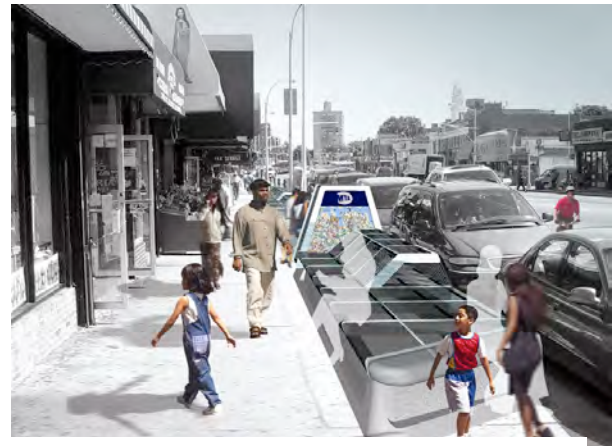
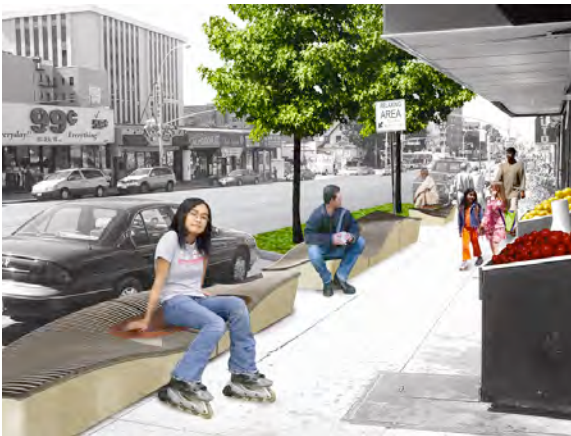
Figures 2, 3, 4

Perhaps a more promising and intriguing solution to the sidewalk grating and station entrance water inflow problem is already being pursued in conjunction with NYCDOT. In fact, in the last week the MTA, NYCT, and NYCDOT have co-sponsored a design charette with top urban designers to develop solutions to the problem. The three conceptual designs they came up with will hopefully lead to a more refined alternative that will address both pedestrian impact and neighborhood aesthetics (Figures 2, 3, 4). The MTA has already begun to work with the city and the Art Commission, which reviews all such street fixtures, and we expect that in the next 30 days we will follow the more formal review process to come up with a final product that works for all. ▼

Renderings of grating protection designs by Antenna Design (upper left), Grimshaw Architects (above), and Rogers Marvel Architects (left).

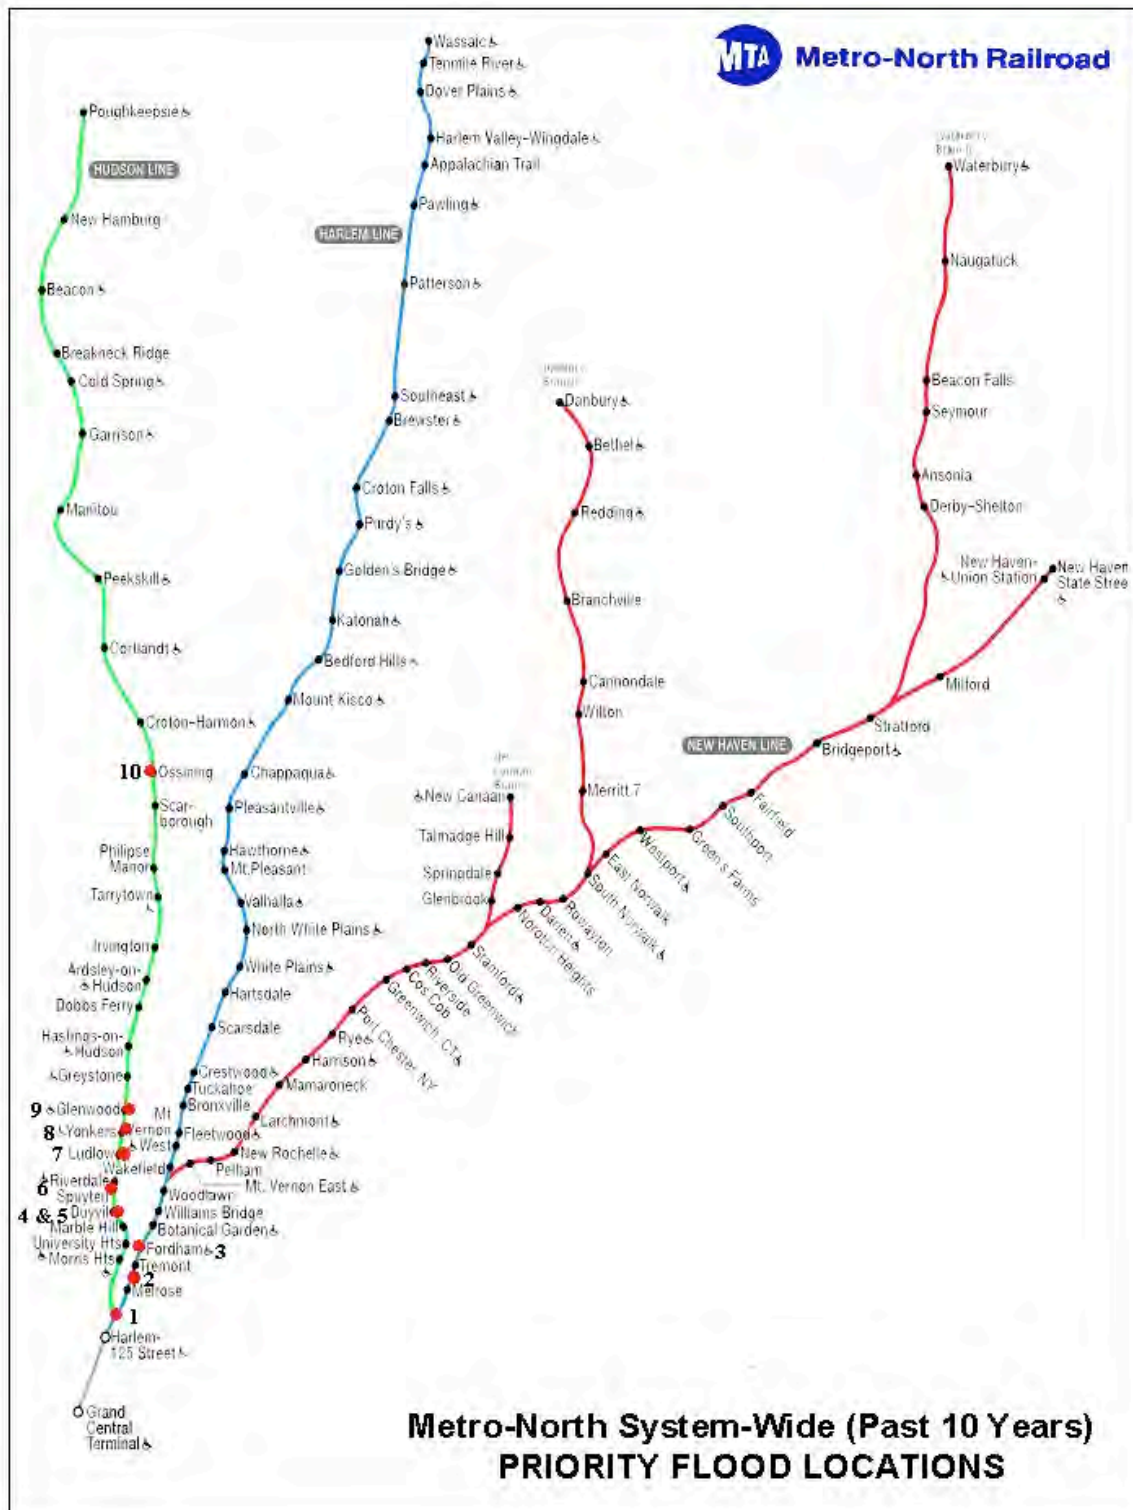
Exhibit 3

Exhibit 3**Table 3 – MTA Metro-North Railroad –
Flooding Incidents by Location**

Location		Cause
MNR August 8, 2007 Flooding Locations		
1	Mott Haven Yard/149th St.	Possible DEP sewer surcharge
2	Tk 4 – Claremont Parkway MP 7.23	Runoff from roadways
3	Tk 3 & 4 – Fordham Station	Runoff from Webster Avenue/Fordham University/surcharged DEP pipe

MNR Historical Flooding Locations		
4	Tk 3 CP 12 – Spuyten Duyvil	Runoff from roadways/property above mudslide
5	Tk 3 – Spuyten Duyvil MP 11.62	Runoff from roadways
6	Tk 3 – Riverdale at 254th St	Runoff from roadways overflows catch basins and curbing
7	Tk 3 – Ludlow	Runoff from city storage property
8	Tk 3 – Yonkers	Mud: private property. City water off roadway through property.
9	Tk 3 Glenwood at the Park	Runoff from Trevor Park
10	Tk 3 Ossining, br. 31.00	Sing Sing Creek; runoff from roadways

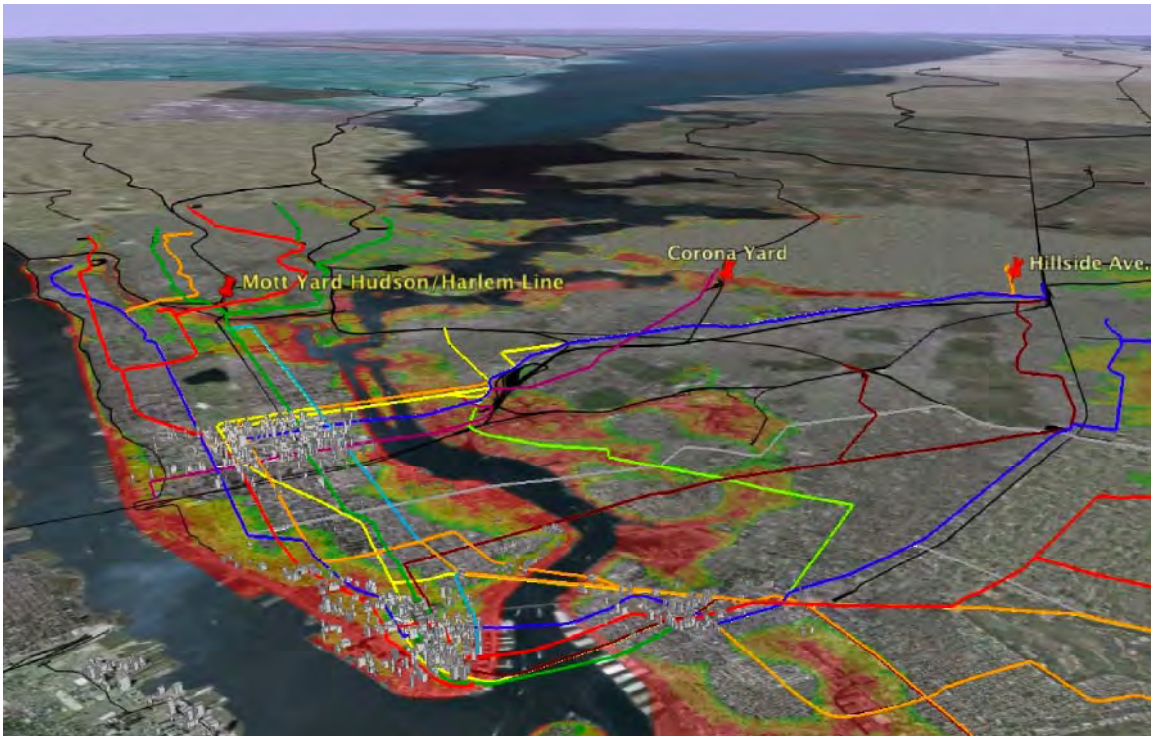
Figure 1: Location of the 3 case study sites: NYCT Hillside Ave. Pump Station on the F-line Metro-North; NYCT / LIRR Corona/Shea Yards – Flushing Meadows, Queens; and Mott Yard (Bronx). Colored areas are worst-track storm surge flood zones for Saffir -Simpson Category-1 in red, SS2 in yellow, SS3 in brown, and SS4 in green. Colored lines are subways, black lines are rail systems. See text for details.

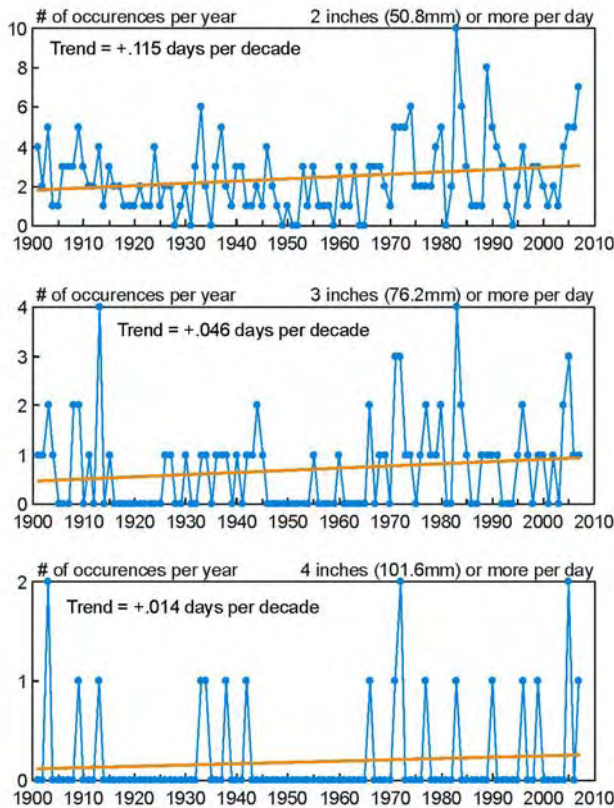
Since extreme precipitation events tend to occur infrequently over small regions, long time series are used to identify trends. Figure 5 shows the number of occurrences per year of precipitation above 2, 3, and 4 inches for the New York metropolitan region since 1900. Trends in extreme precipitation events are all positive, with increases of 1.15, 0.46, and 0.14 days respectively over the period of record. These represent a 48%, 66%, and 78% increases in the average number of occurrences for the three thresholds. Despite the large trends relative to the small frequencies of occurrence, these results are not statistically significant at the 95 percent level. The infrequency of extreme events and the non-normal statistical properties of precipitation set a very high threshold for statistical significance.

Figure 5: Heavy precipitation events in Central Park (1900-2006), based on daily precipitation exceeding 2, 3, and 4 inches.
Source: Columbia Center for Climate Systems Research

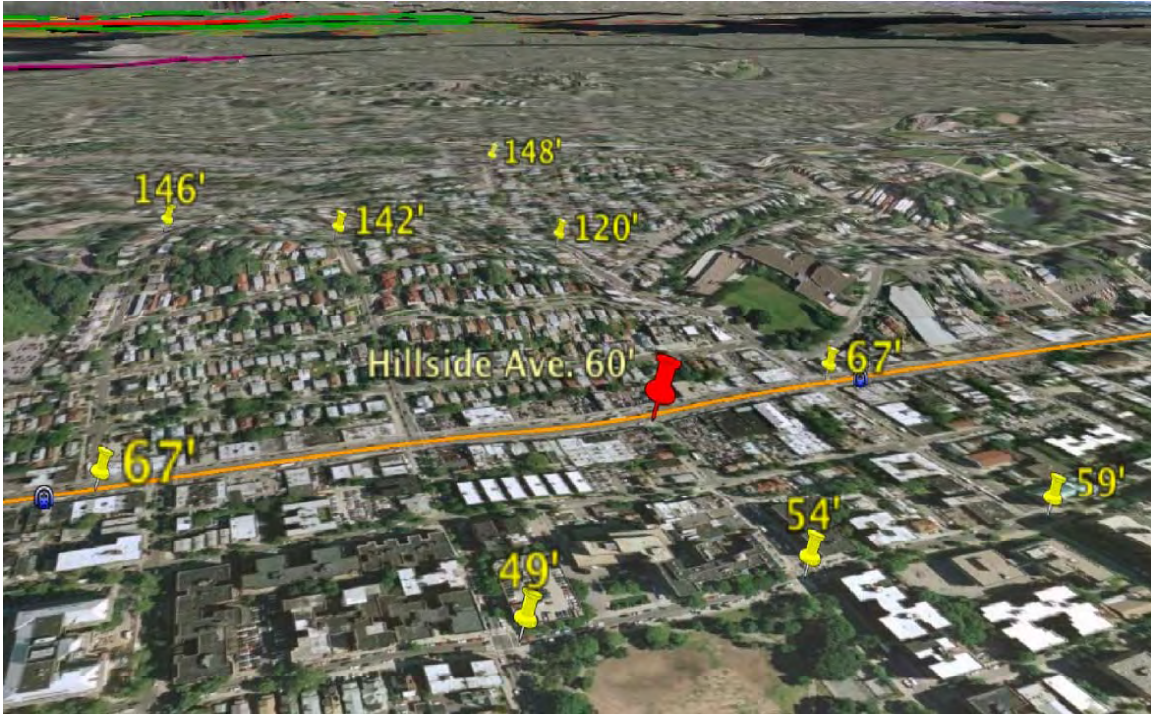
Hillside Avenue in Queens (Figure 12) is representative of a locality that experiences frequent inland *rainfall flooding*. The locality and its surroundings are landlocked with relatively steep surface topography; local maximum slopes are up to 30%, and average slopes a few percent, yielding elevation ranging from between 54 and 145 feet above mean sea level.

Figure 12: Hillside Avenue, Queens, with F-subway (orange-brown line) and elevations (ft) for selected points. The NYCT Pump Station is below the red pin, where Hillside Ave. and the F line tracks (which are 30 ft below grade) are the lowest. Run-off from the terminal moraine hills to the north contributes to the flooding. See text for details.

The projected increase in the number of days per year with heavy precipitation (i.e. more days with more than 2 inches of rain per day) suggests that flooding conditions at Hillside Avenue are likely to worsen with time unless mitigated. Generic options for risk reduction are discussed in a later section.
